CANADIAN FORCES FLIGHT SAFETY INVESTIGATION REPORT (FSIR)

FINAL REPORT

FILE NUMBER: 1010-Gliders (DFS 2-4-2)
DATE OF REPORT: 1 April 2005

AIRCRAFT TYPE: Schweizer 2-33A Glider, C-FEAF
DATE/TIME: 081615Z July 2003
LOCATION: St Jean Airport, Québec
CATEGORY: "A" Category Accident

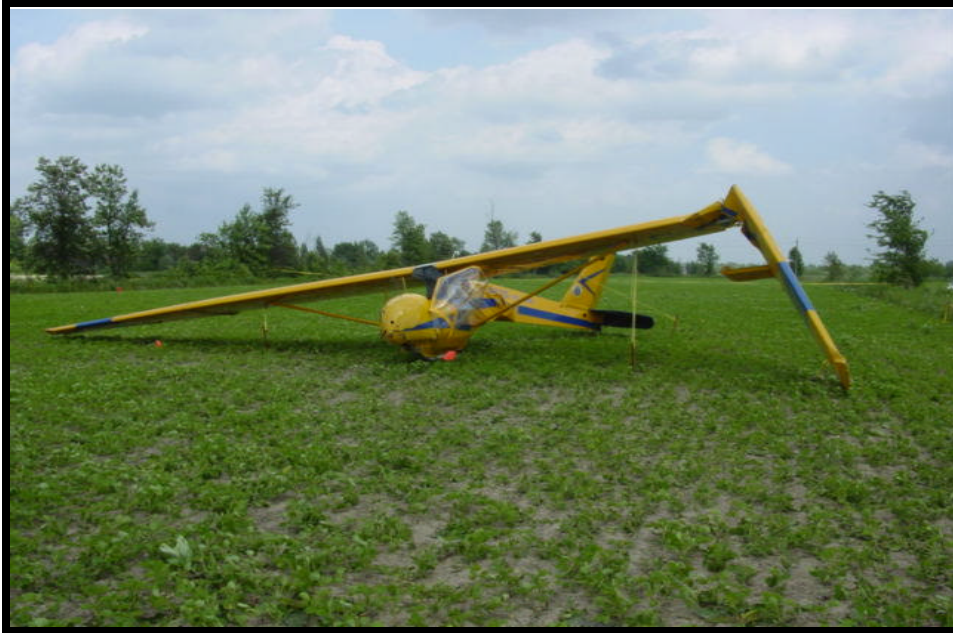
The aircraft received “A” category damage (Photo 1). Both wing tips contacted the ground, the left wing broke in two pieces at the inboard end of the aileron, and the underside of the nose cone was pushed inward. The right wing tip fairing received minor damage and buckled at the inboard end of the aileron. The rear fuselage bent at the midpoint (Photo 2).

Photo 1: Final Resting Place

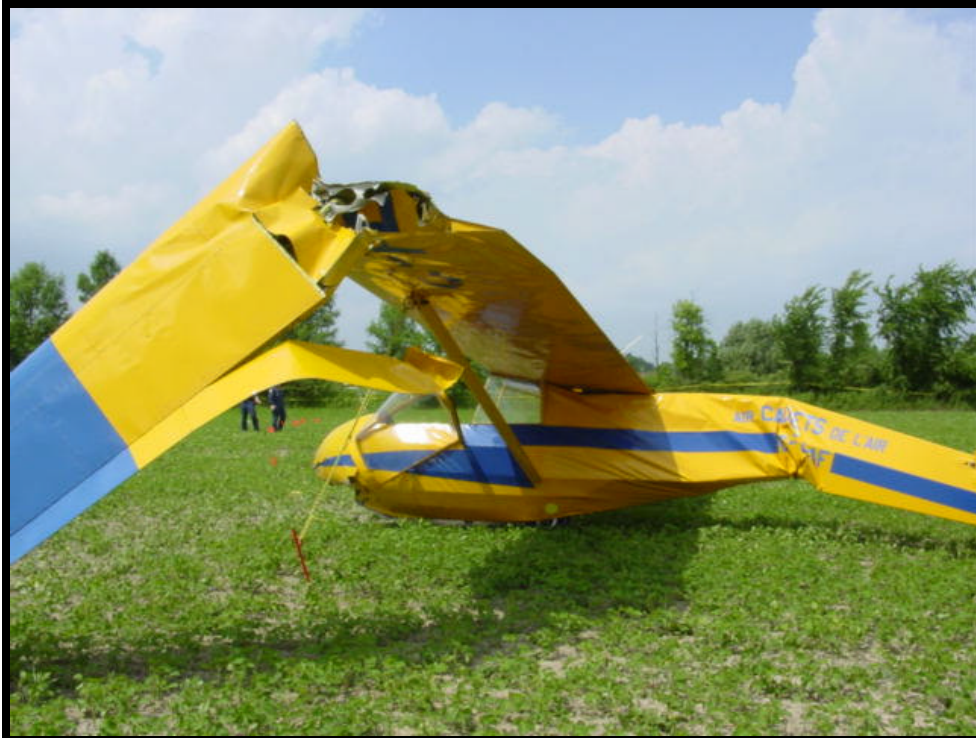
The glider was in a medium to steep left turn when, at some point during the turn, the left wing impacted the ground with approximately 45° angle of bank or more. This impact caused the wing to snap at the mid point and the glider to cartwheel. The nose then impacted the ground at a relatively steep angle with sufficient force to snap the tail of the aircraft at the mid point along the fuselage. The aircraft continued to cartwheel, becoming briefly airborne with sufficient energy to complete a 180° turn counter clockwise prior to its final ground impact. The glider came to rest along the final approach path.

Photo 2: Left Wing Damage

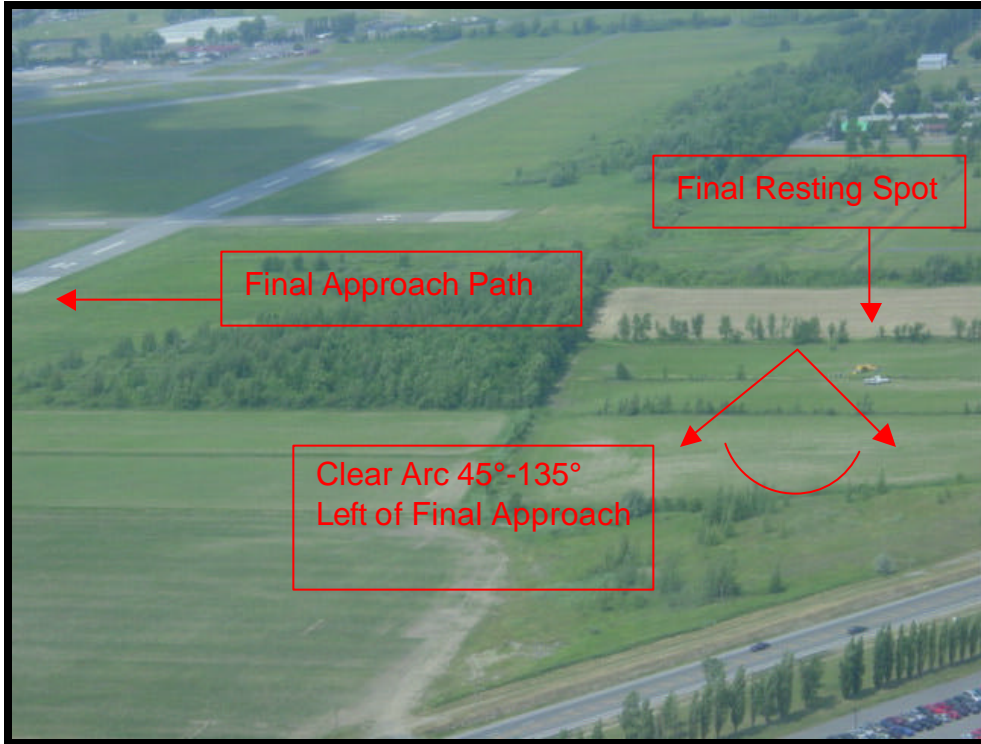
An open field is present to the left of and parallel to the final approach path of Rwy 1 (photo 3).

Photo 3: Clear Area to Left of Approach
